Progress Update

Nitrogen Extraction from Water

by an Innovative Electrochemical System

19 November 2019

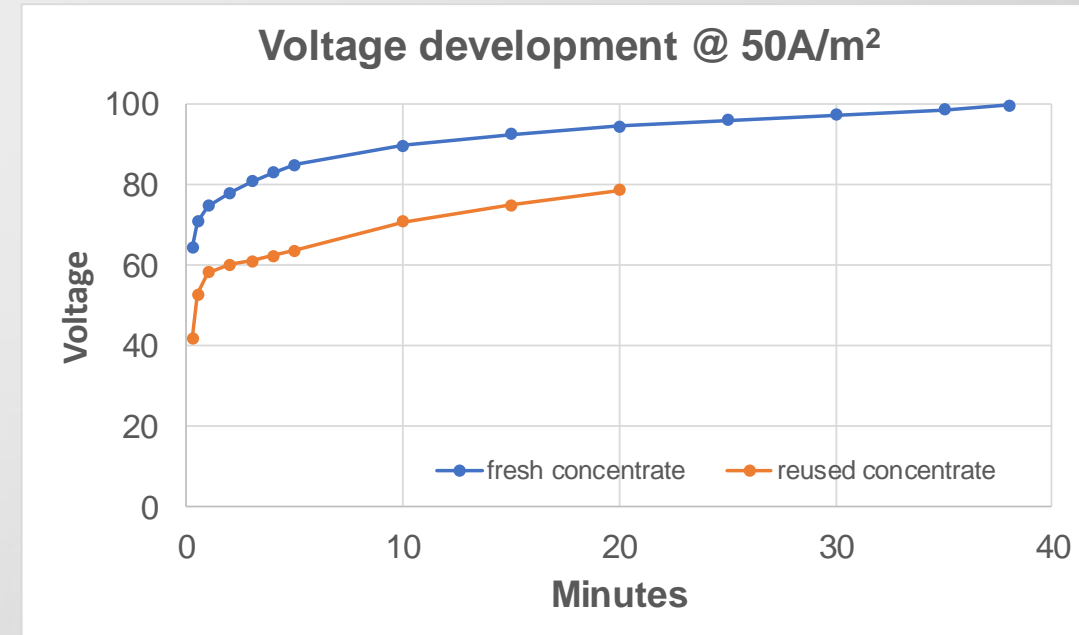
Operational Voltage Window

Conductivity lower than anticipated

- Requires higher voltage to drive current through stack
- Larger transport number w.r.t. calcium

Power supply limited to 100V

- Won't allow testing over relevant time intervals beyond 50A/m^2
- May increase relative share of ionic shortcut through concentrate

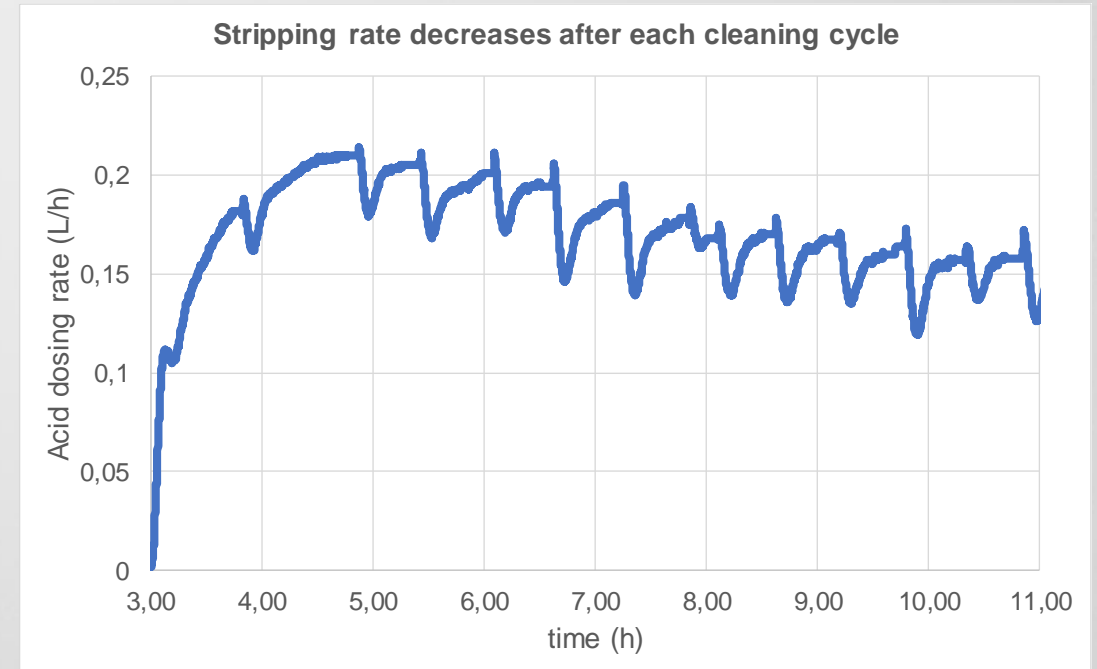
Slow resumption/decreased rate of stripping after cleaning

- Increase in conductivity cation concentrate after cleaning due to carry-over
- Resumption of stripping became progressively worse:
 - Carry-over of rinsing acid leads to lower pH of cation concentrate: needs to be neutralized
 - Higher osmotic pressure difference between feed and concentrate causes increased water transport, diluting concentrate over next run
 - Co-ion transport of chloride over CEM may decrease ED selectivity
 - Greater difference in conductivity between feed and concentrate enlarges ionic shortcut issue

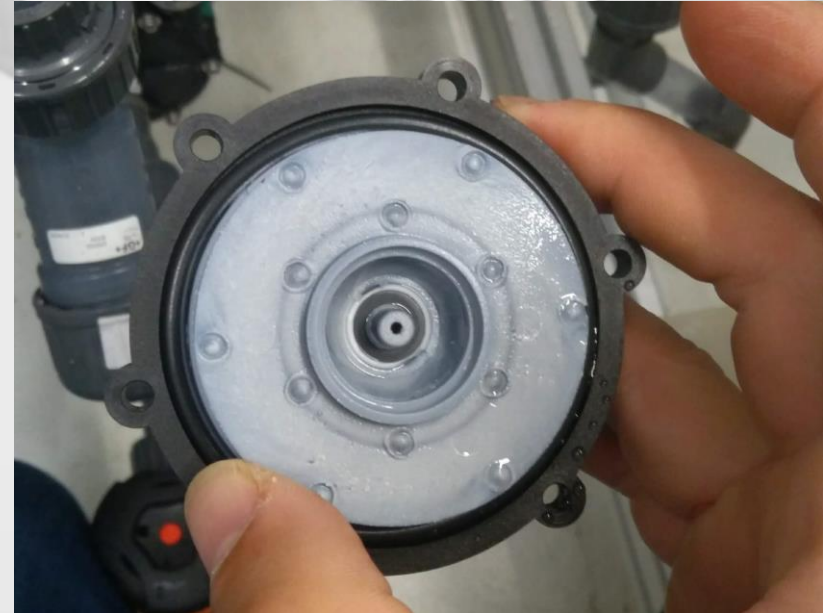
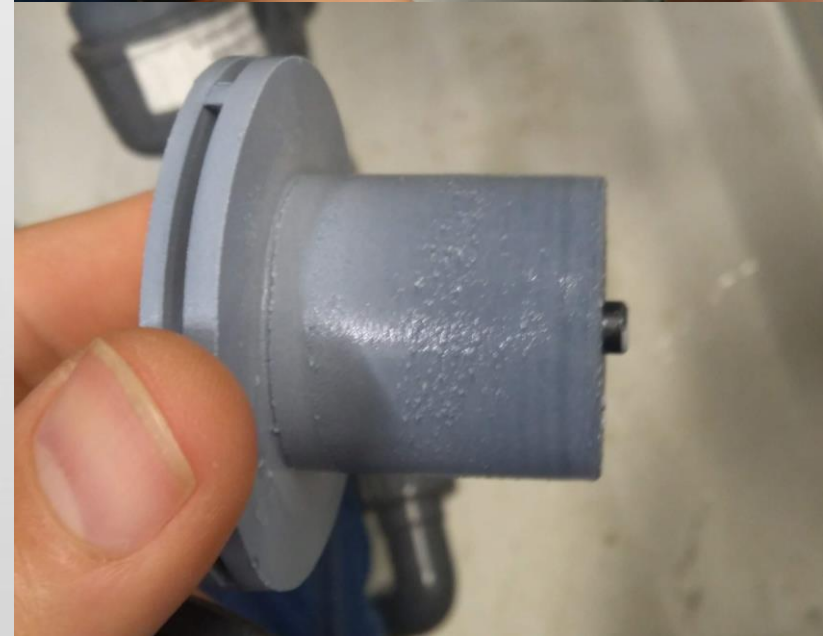
Pump and flow sensor failure

- Precipitation of calcium carbonate caused issues with moving parts in cation concentrate flow:
- Gradual decrease of recirculated flow rate, independent of cleaning
- Complete blocking of pumps. Recovered by cleaning with acid
- If only pumps are cleaned, eventually also flow meters get stuck
- Rate of precipitation within pumps strongly dependent on amount of cleaning cycles and operation of stack:
 - ✓ Keep current going
 - ✓ Don't backwash concentrate through pumps
 - ✓ Prevent carry-over of rinsing acid

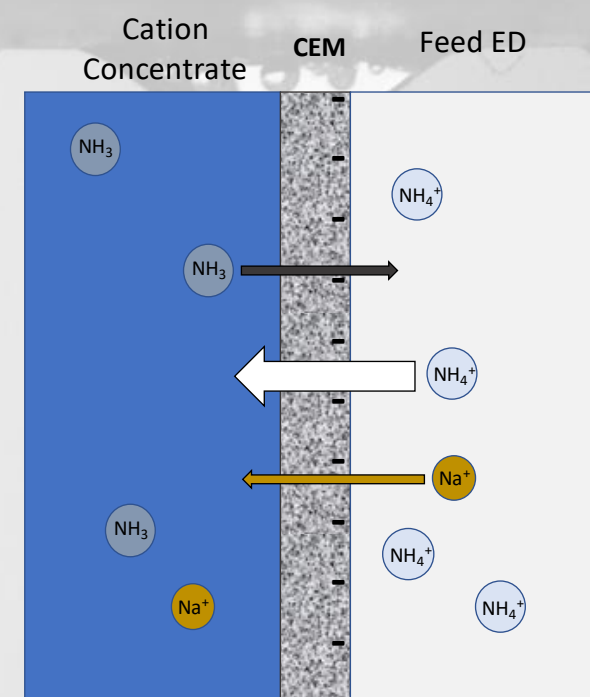
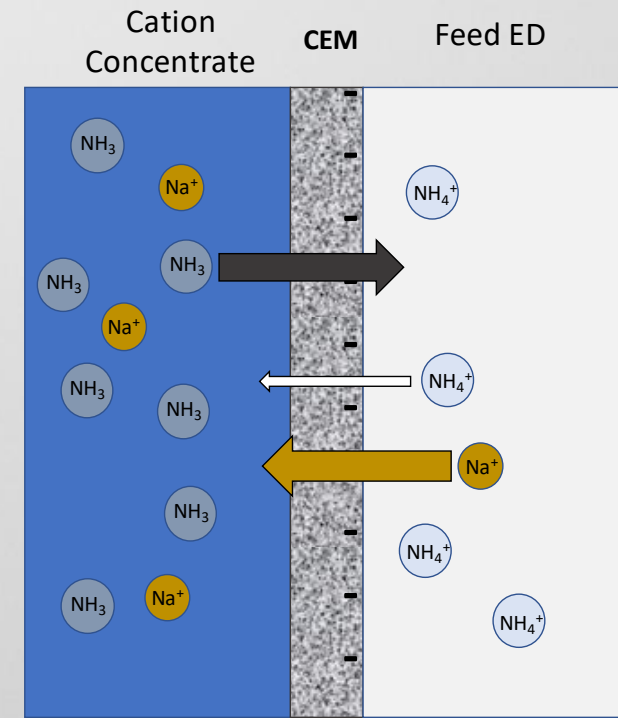
Effectiveness of currently used TMCS

When NH_3 not sufficiently stripped, higher concentrations accumulate in concentrate, leading to:

- higher concentrations of co-ions:
 - Larger water transport
 - Higher pH
 - Larger absolute transport number of co-ions (lower CE)
 - Larger calcium deposits (scaling issues)
- (Back)diffusion of NH_3 from (cation) concentrate to diluate (Feed ED)
