Progress Update

Nitrogen Extraction from Water

by an Innovative Electrochemical System

19 November 2019

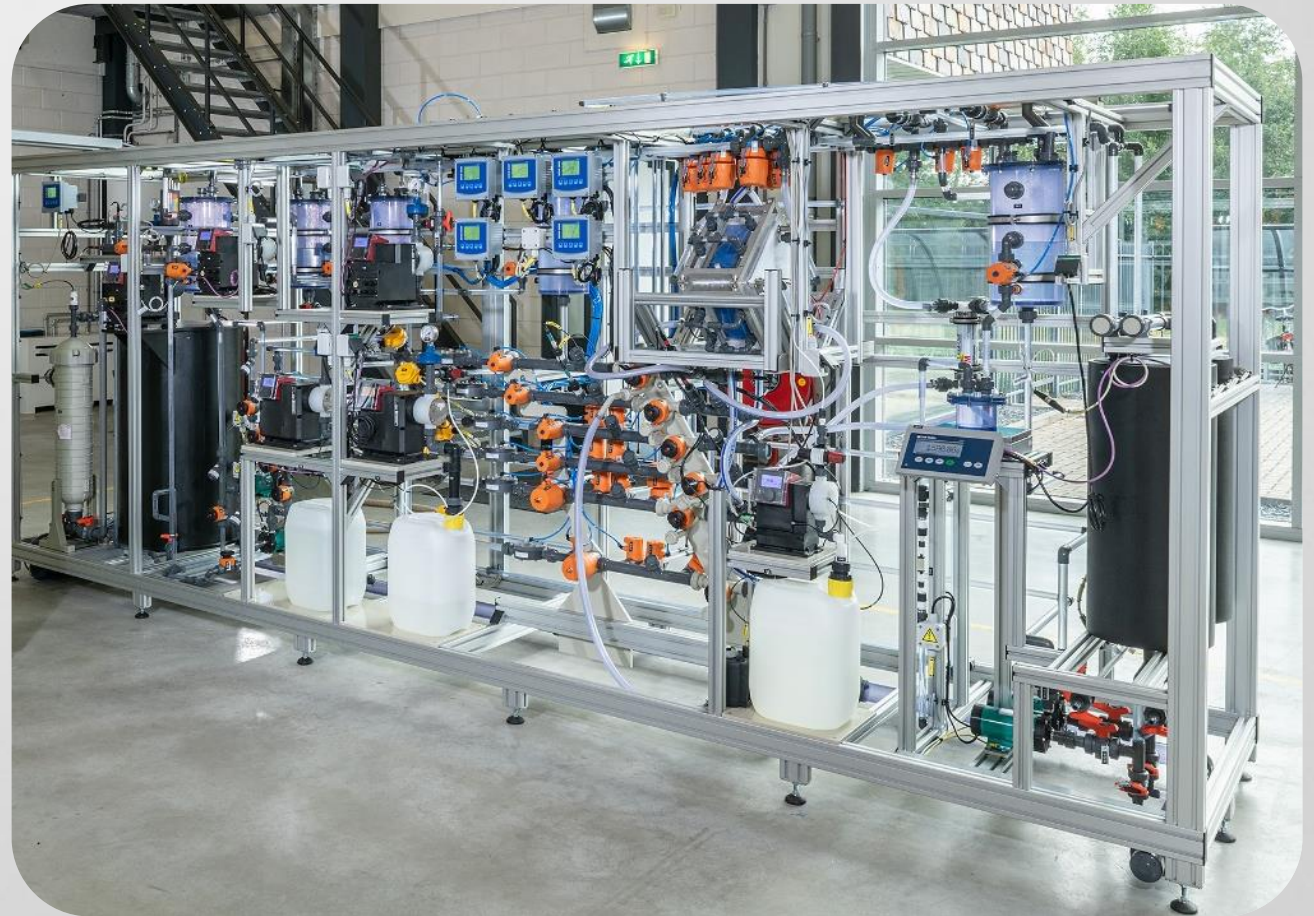
Initial operational strategy

Pilot designed to control process with:

- (1) Conservation of cation concentrate throughout cleaning cycles
- (2) Cleaning of stack/TMCS triggered by:
high voltage on stack
Time interval on TMCS
pressure drop of recirculate pumps
- (3) Only TMCS and Stack compartments included in cleaning

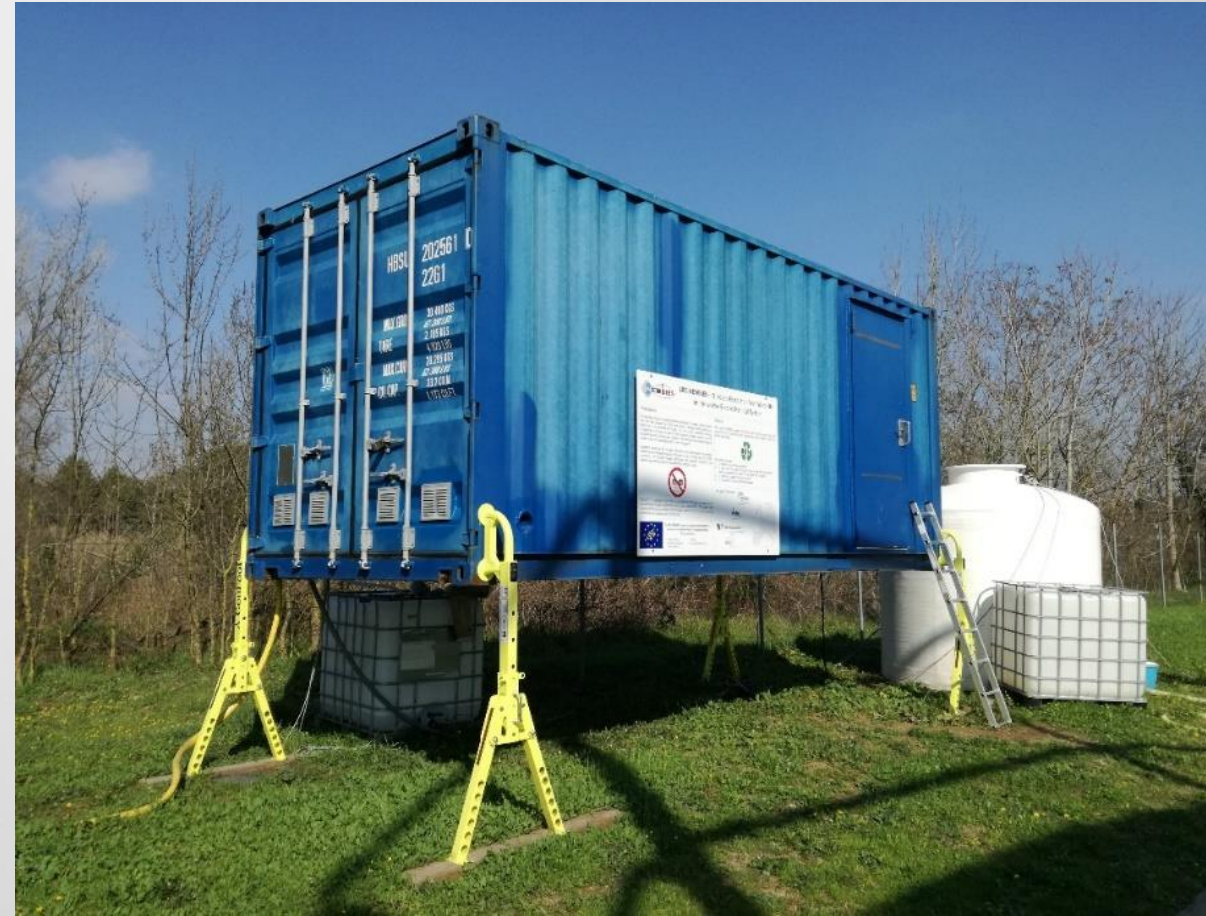
Practical issues encountered

1. Small voltage window at required current density led to very frequent cleaning of stack
2. Fast onset and rate of flow reduction led to frequent cleaning or required substantially decreased flow rates
3. Slow resumption and (progressively) decreased rate of stripping after cleaning cycles
4. Progressive shortening of runs throughout cleaning cycles
5. Pump and flow sensor failures
6. Doubts about LLMC performance
